**Walworth County  
Land Conservation Committee Meeting  
Monday, March 18, 2013 at 2:00 p.m.**

**CERTIFICATE OF COMPLETION**  
**Reclamation of a Nonmetallic Mining Site is Complete**  
**Burdick Trucking and Excavation, Inc., Mining Site Operator**  
**Baker Enterprises, Owner**

Subject: Nonmetallic Mining Reclamation (NR 135) Program Review for Walworth  
County (RA # = 55-127-00000)

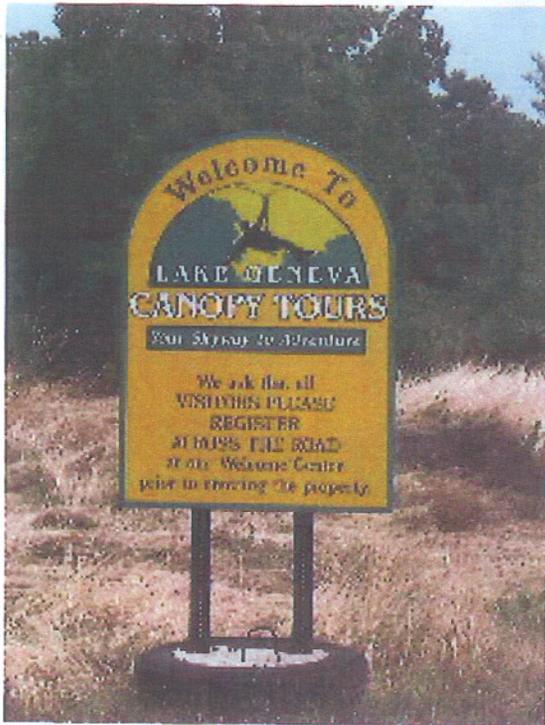
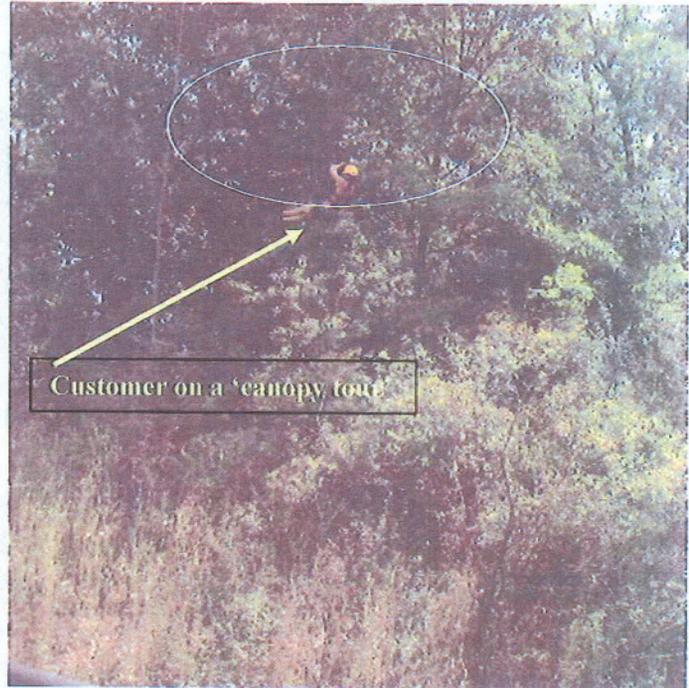
Photos Nos. 1 & 2.

**Site # 1.** This reclaimed minesite (permittee was a B.R. Amon and Sons, Inc.). Site is located on County Road H near Elkhorn in the Town of Geneva. Walworth County issued a COC and released the FA finding the site was successfully reclaimed to its post mining land – use: recreational. The site now supports *Lake Geneva Canopy Tours*. This unique reclamation offers multi-recreational use with 8 zip-lines that carry users from platform to platform. It is used year-round open to hikers and bikers. Fay and I met with **Phil Kroll**, Course manager of the Lake Geneva Canopy Tours (this multi-recreational use site features 8 zip-lines that carry folks from platform to platform may be used year round as it is open year-around to hikers and bikers.

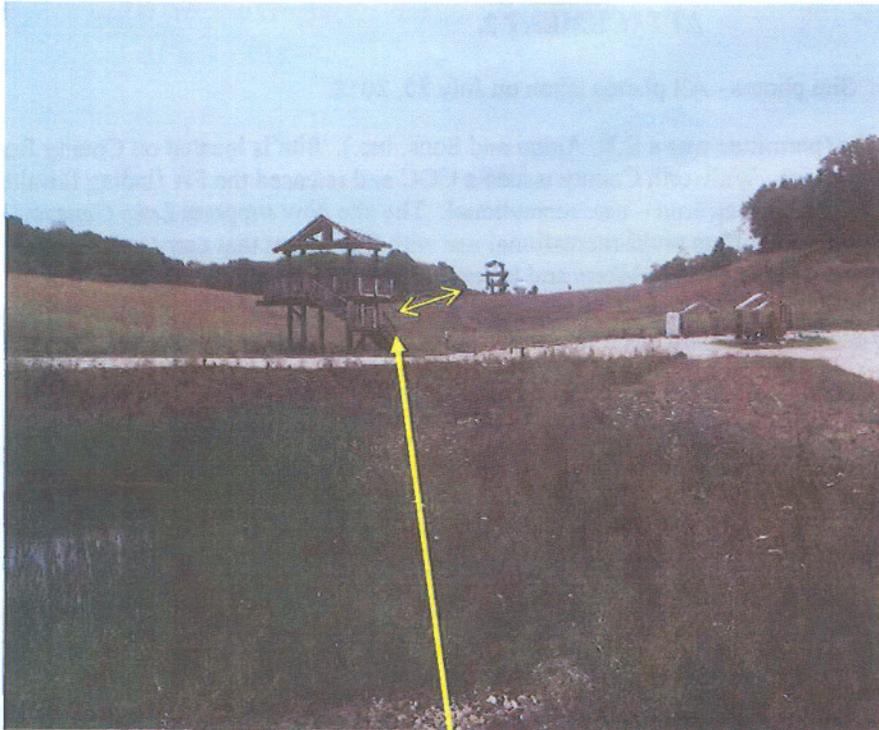
**Photo No. 3.**

Reclaimed nonmetallic mine site now supports a recreational land use and is managed by *Lake Geneva Canopy Tours*.

Sloped and revegetated slopes on either side are evidence of past mining and its successful reclamation.

**Photos Nos. 3 & 4.** These depict the interval between platforms at this final portion of the course is 1,200 feet long and users reach speeds of 45 mph.

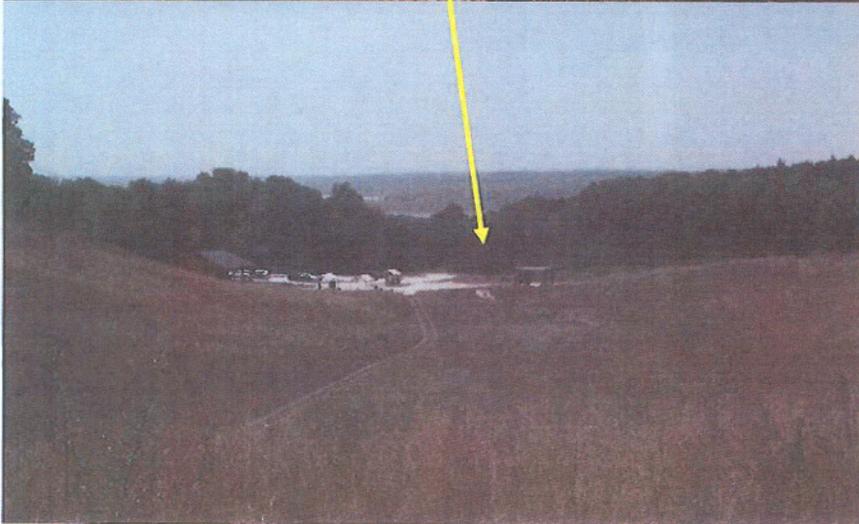
**Photo No. 4.** View from upper platform shows length of course with Lake Como visible to the Southeast.

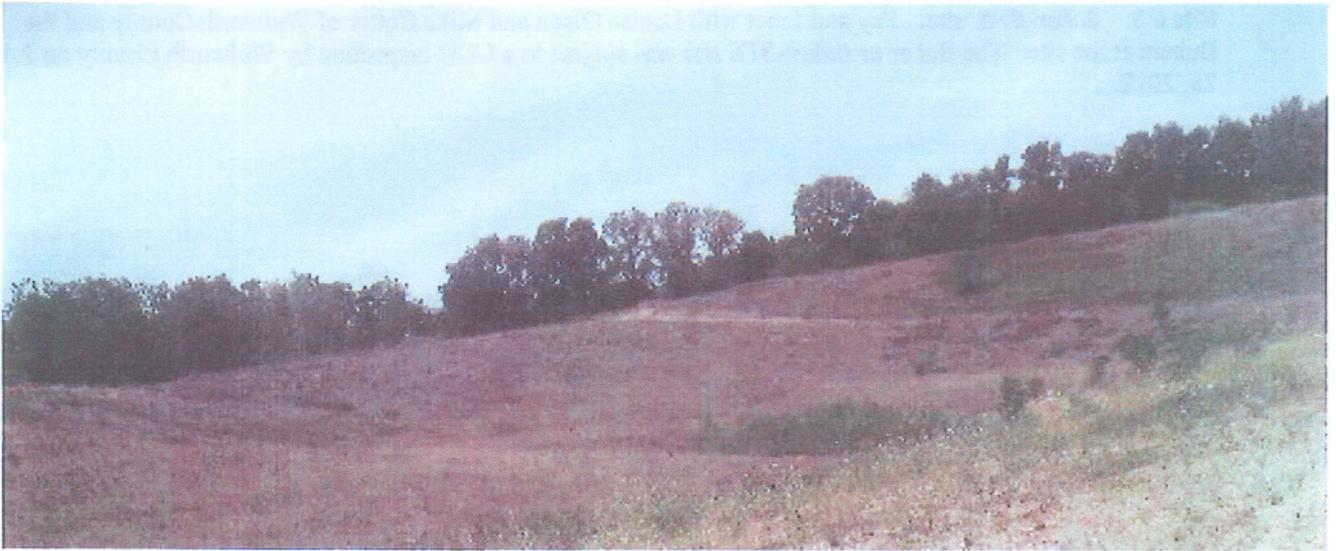
**Site # 2. Photo No. 5.** The Amon site that has post mining land use slated as a future residential development. Ultimate land use to be residential but currently maintained in a stable state. Areas where roads will be are left stable but not entirely vegetated.

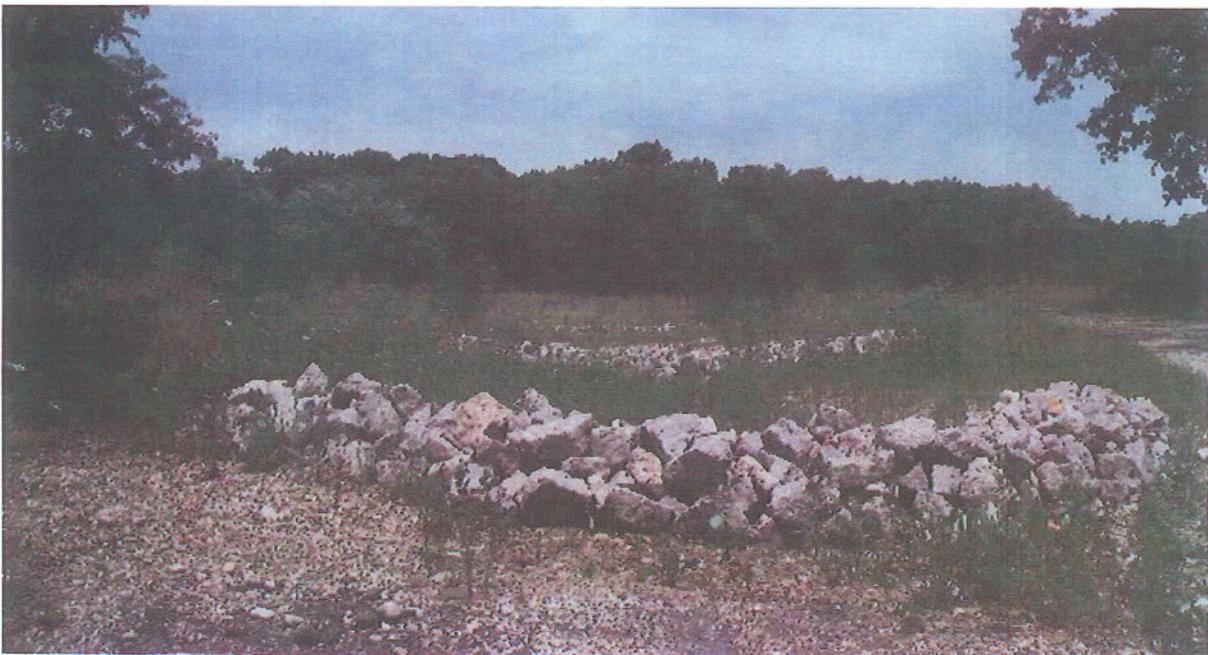
**Site # 2. Photo No. 6.** The reclaimed Amon site. During this indefinite period the site is well protected from erosion as evidenced by this series of rip-rap energy dissipater check dams.

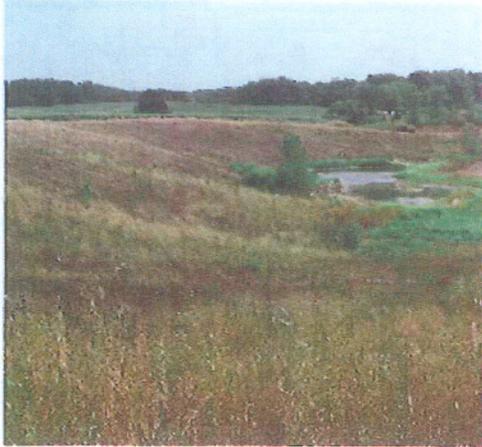
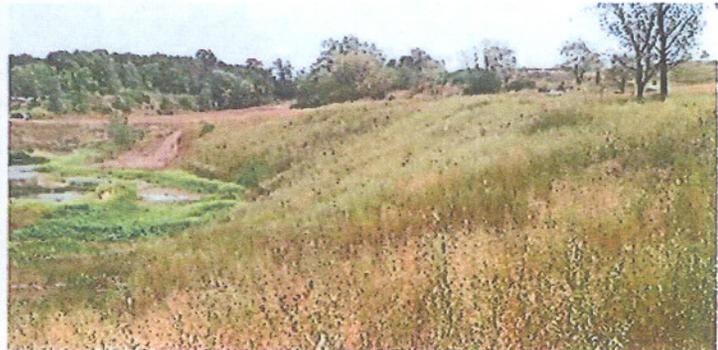
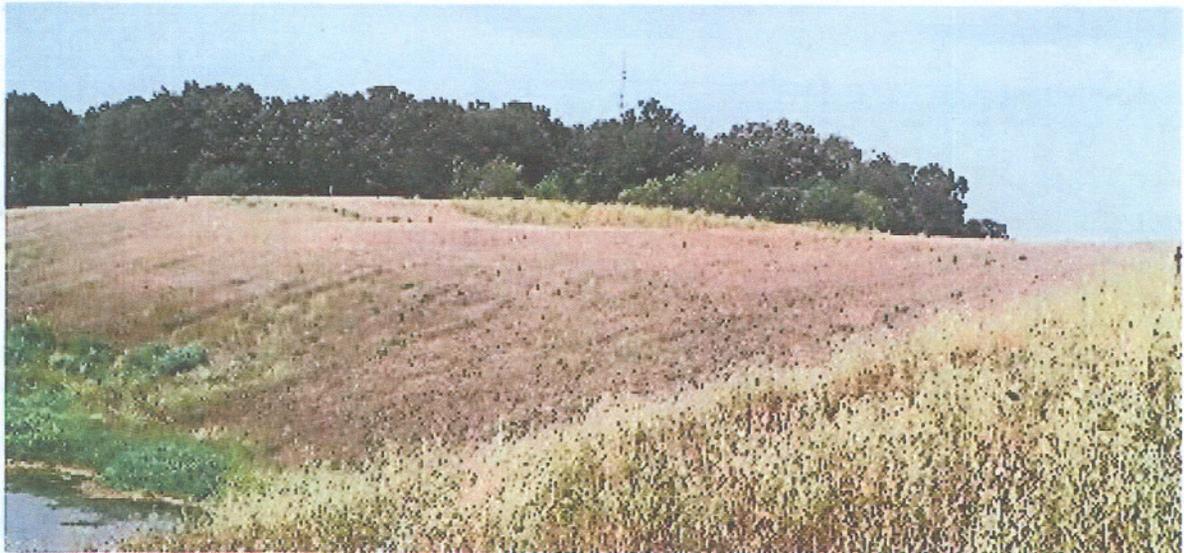
**Photos Nos. 7 - 9.** Site now reclaimed and stable. County's evaluation method for determining reclamation success which includes evaluation of vegetative cover combined with overall site stability. (For additional detail please see **Attachment 3**).

**Site # 3.** The *Baker-BTE* site, Fay and I met with Louise Olson, Mike Cotter and the Bakers (site owners) at the reclaimed mine located near the intersection of State Highway 14 and County Highway K. Reclamation of this site was done by Burdick Trucking and Excavation, Inc., the NR 135 reclamation permit holder. On July 25, 2012 during the site visit the *Baker-BTE* site was subject to a COC evaluation inspection by Walworth County staff. I observed the method of determining reclamation success which includes vegetative cover combined with overall site stability so as to determine if the reclamation of the *Baker-BTE* site was successful and warranted the issuance of a COC.

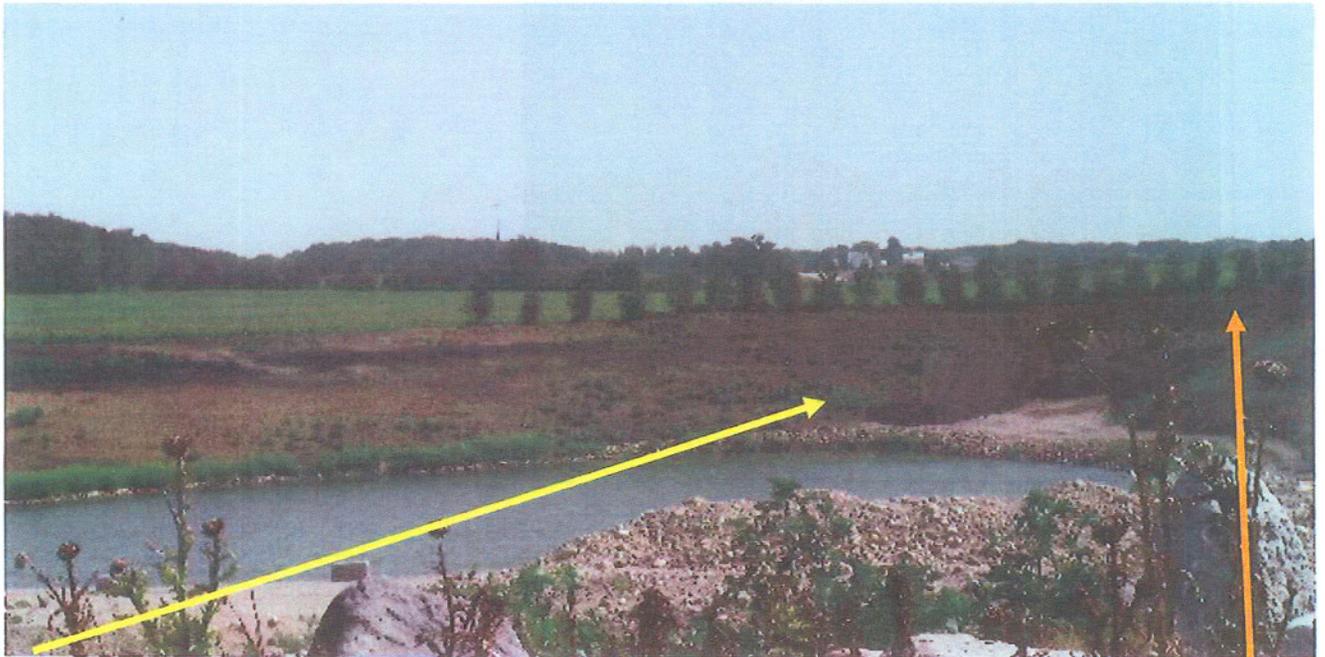
**Photo 10.** Permittee currently engaged in contemporaneous reclamations was required in both the original CUP and in the ore recent NR 135 Reclamation Permit. This has been neglected until the recent past. However, at the time of my site visit a couple stages of land restoration of mined out areas (previous phases) had occurred or was occurring. Soil is being brought in from constructions sites being distributed for reclamation along side of pond. Trees in center above excavated area have been there for some time.

**CUP issues require resolution –in progress.**

Concrete being recycled part of resolution of a pending CUP matter.

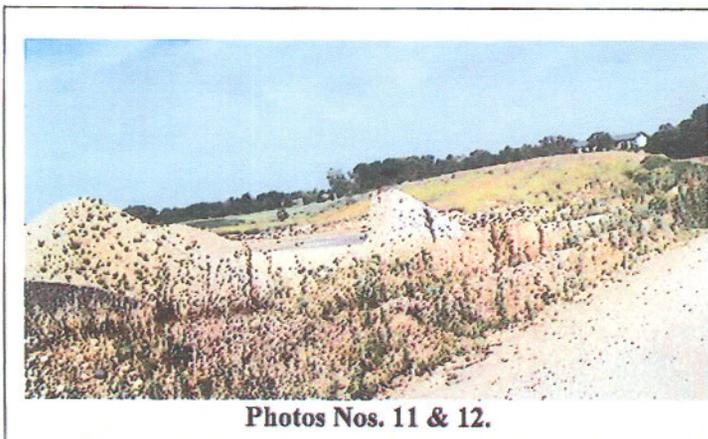
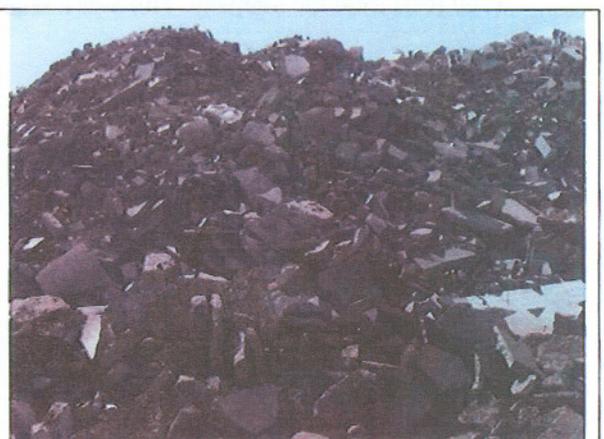
**Photos Nos. 11 & 12.**

I observed removal or timber matts, the distribution of topsoil for the purpose of site reclamation and areas that have been planted in the lat few months. (See photos 10 - 14).

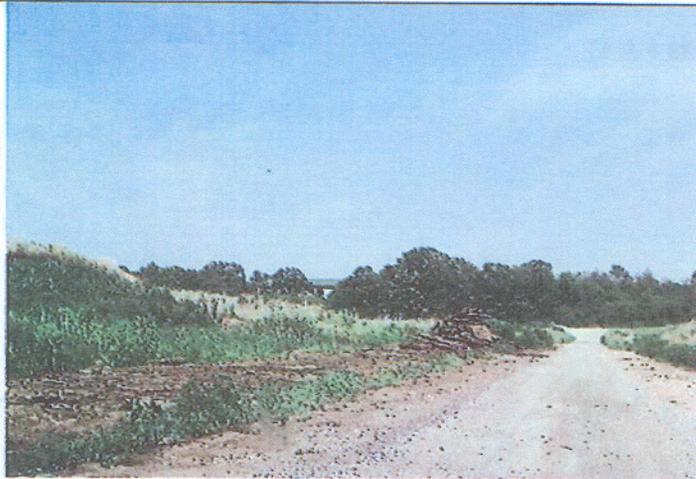
**Photo No. 13.** Area from which timber matts were removed

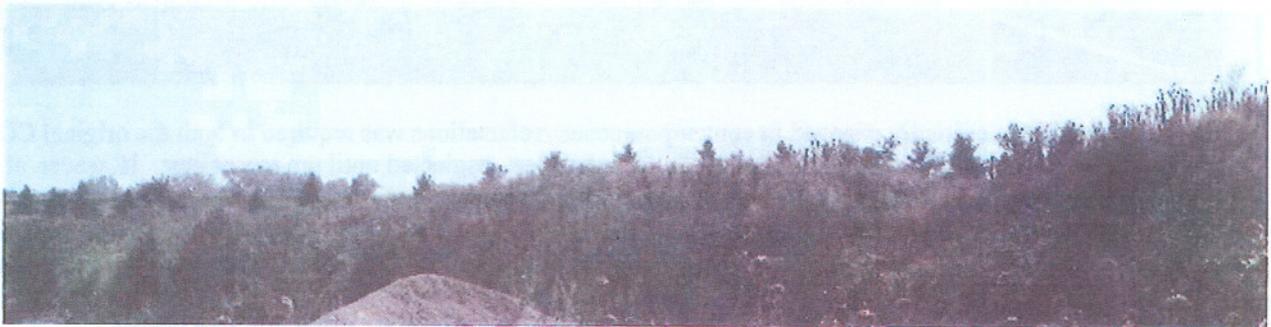
**Photo No. 14.** Soil berms (topsoil to be used in final reclamation) are in place at the required distance from (100 feet) from the highway. This was a requirement of the original CUP.

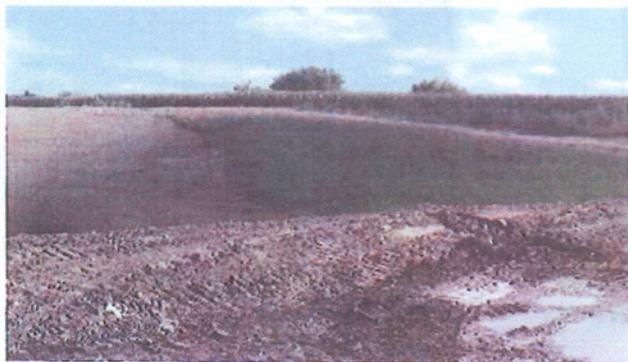
**2011**

Reclamation, slope stabilization and revegetation activities that were taking place during my site visit. Photo taken during my site visit on September 6, 2011.

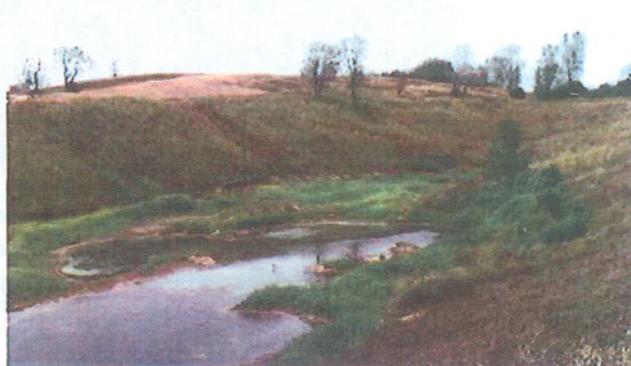
**2012**

The above photo was taken on July 25, 2012 during the NR 135 Reclamation program review audit.

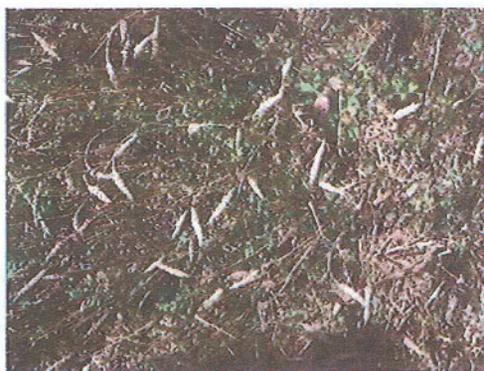
**2012 close-ups of erosion mat and vegetation.**

Nurse crop planted last year is still and has worked to promote site stability and cover for emerging seedlings. With recent rain after protracted drought – one can observe the emergence of plants that were contained in the approved WisDOT seed mix<sup>5</sup>.

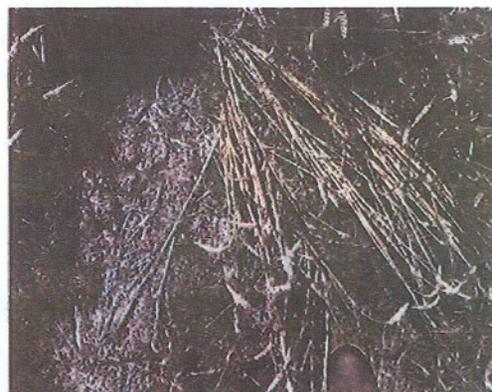
Erosion mat still visible and appears effective in stabilizing the site during the period of revegetation.

As part of the NR 135 program audit and as the result of the reclamation I observed in the field on July 25, 2012 it appears reasonable and advisable for the county to issue a COC for this site. There was no question as to the overall stability and therefore overall-safety. Vegetation is doing well despite drought and looks to be improving in response to belated precipitation. It appears that the reclamation work in 2011 at the *Baker-BTE* site has achieved its objective with the former mine site having been restored to a productive and stable state and a productive post mining land use.
